**Board of Equalization Building**  
450 N Street, Sacramento, CA 95814  
**Corroded Drain Line Investigation**  
**Prepared for DGS**

Interactive Resources Project No. 2011-099-01  
IDGS Contract No. 3158936 (BPM #028)

November 25, 2013

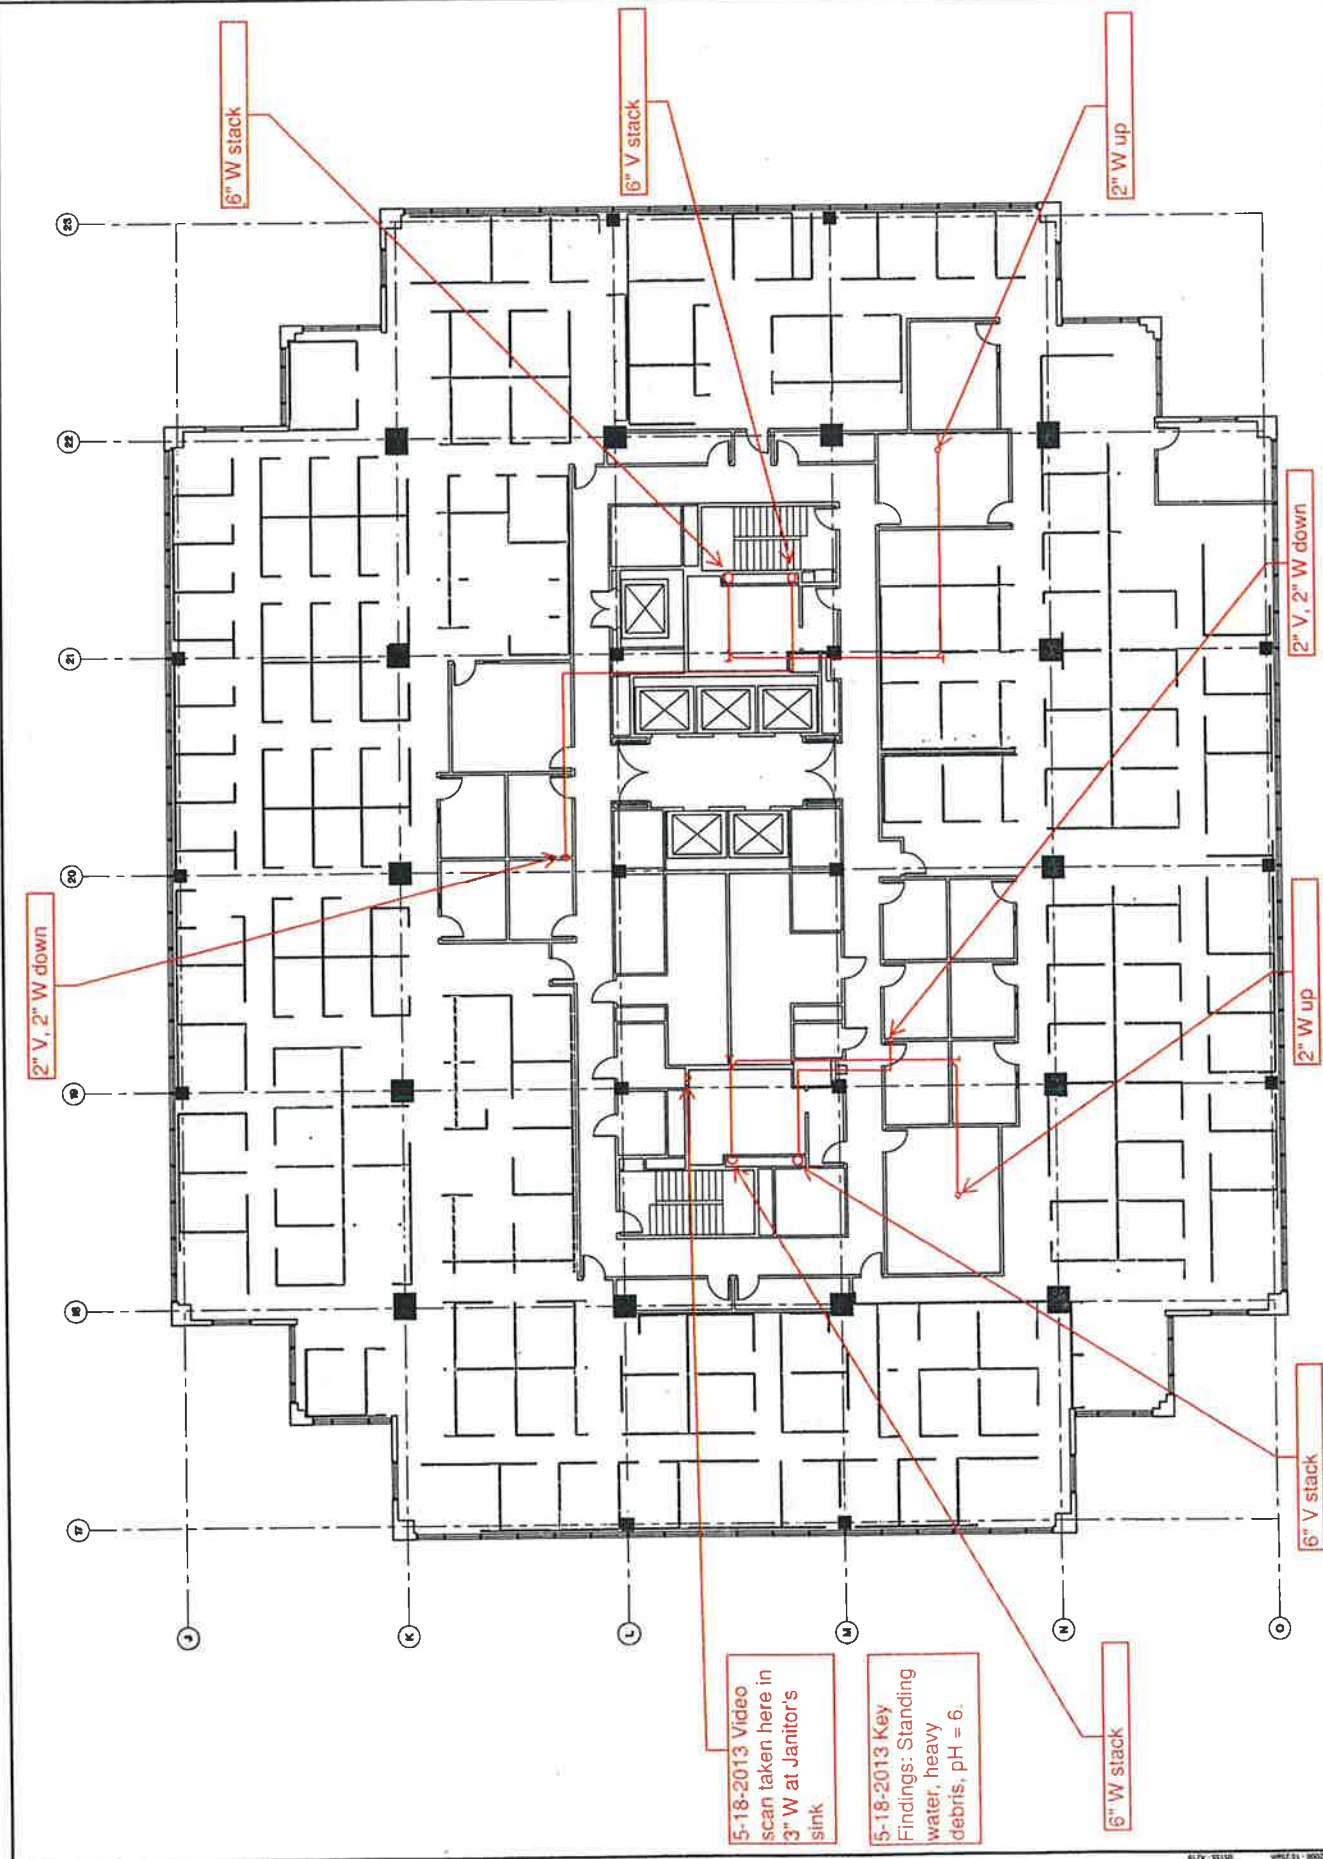
A219

5-18-2013 Video  
scan taken here in  
3" W at Janitor's  
sink

5-18-2013 Key  
Findings: Standing  
water, heavy  
debris, pH = 6.

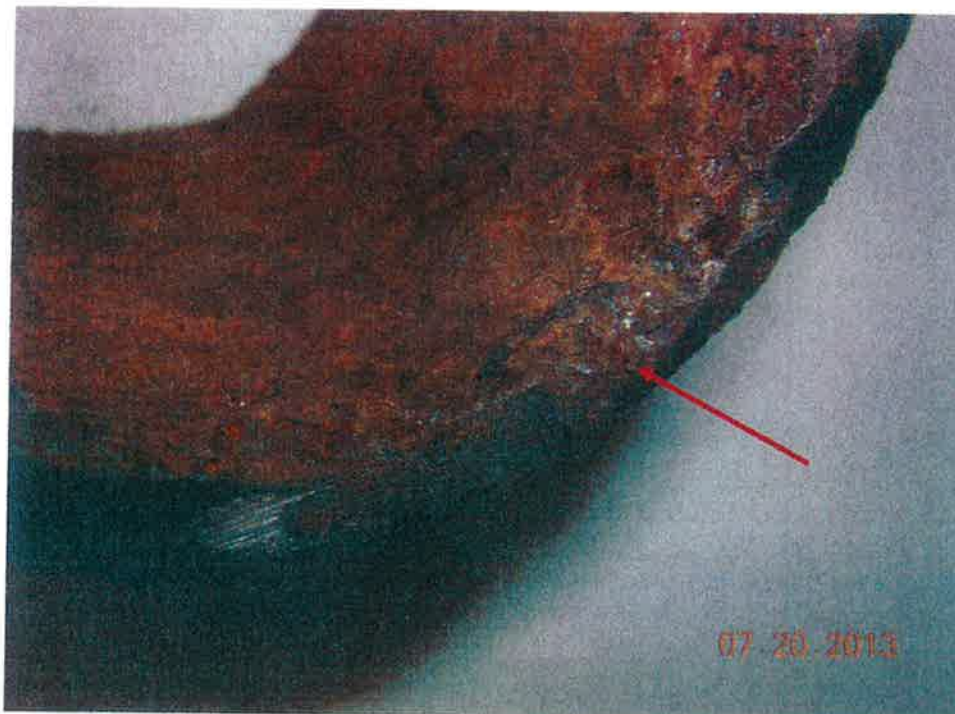
Photo 15 - Sample 4 - Edge Corrosion

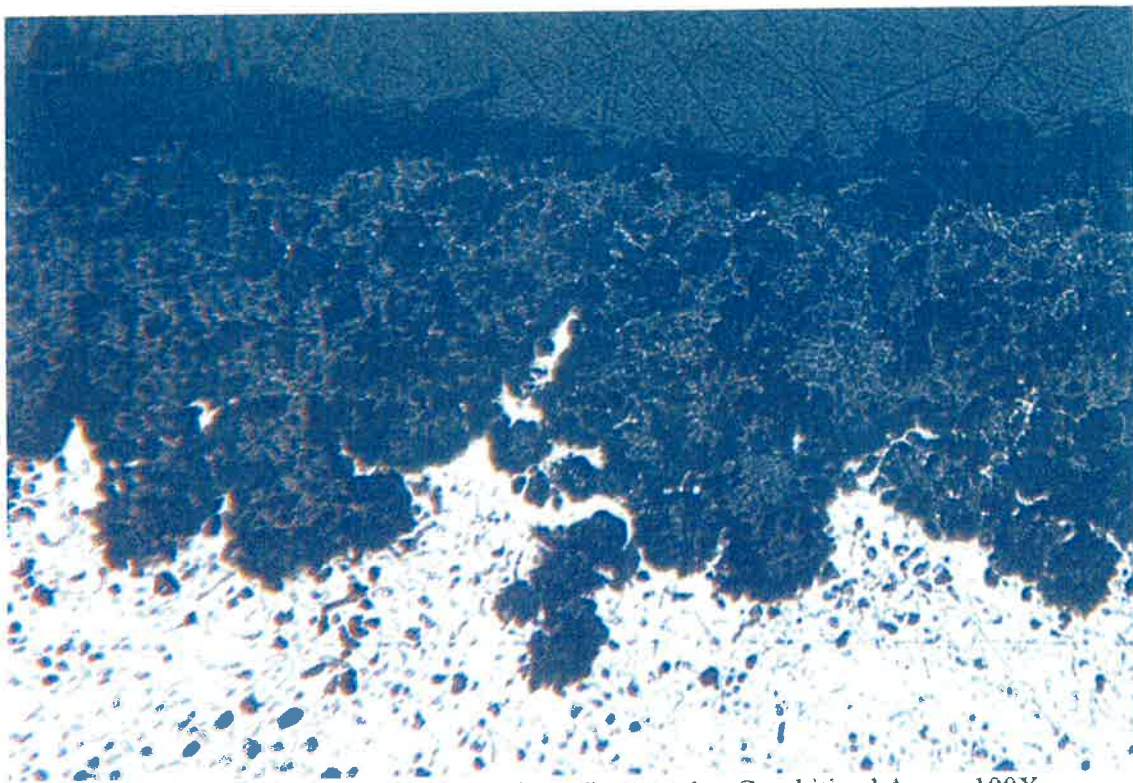
Photo 78 - Sample 2 - Cross Section Micrograph - Graphitized Area - 100X

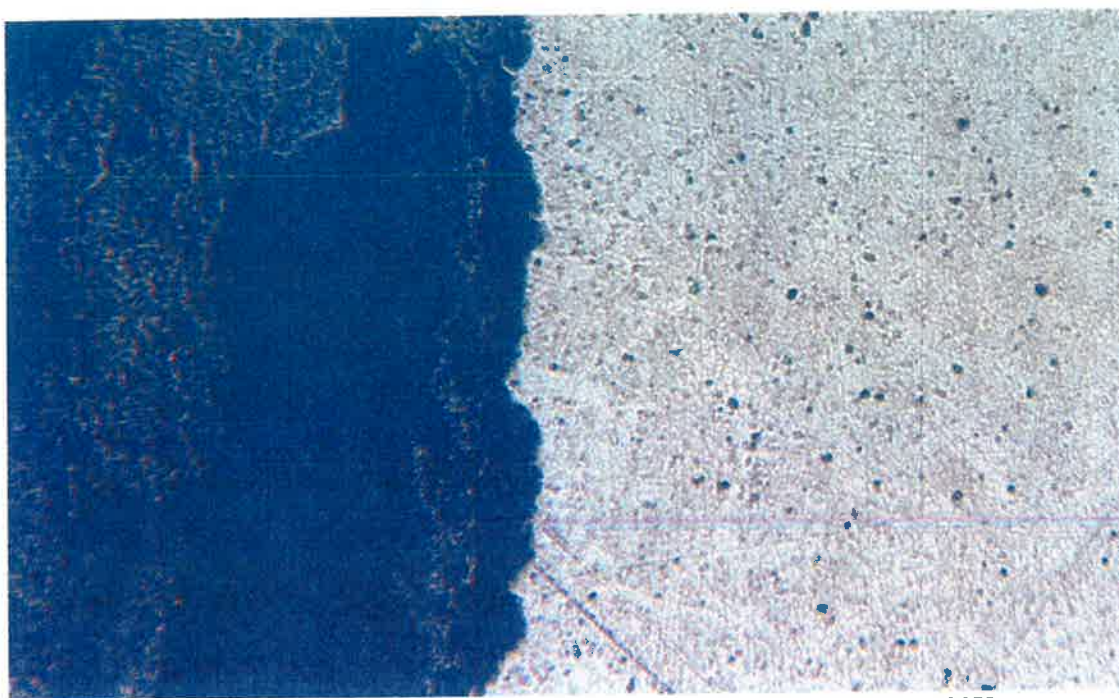
Photo 80 - Sample 4 - Cross Section Micrograph - Pitted Area - 100X

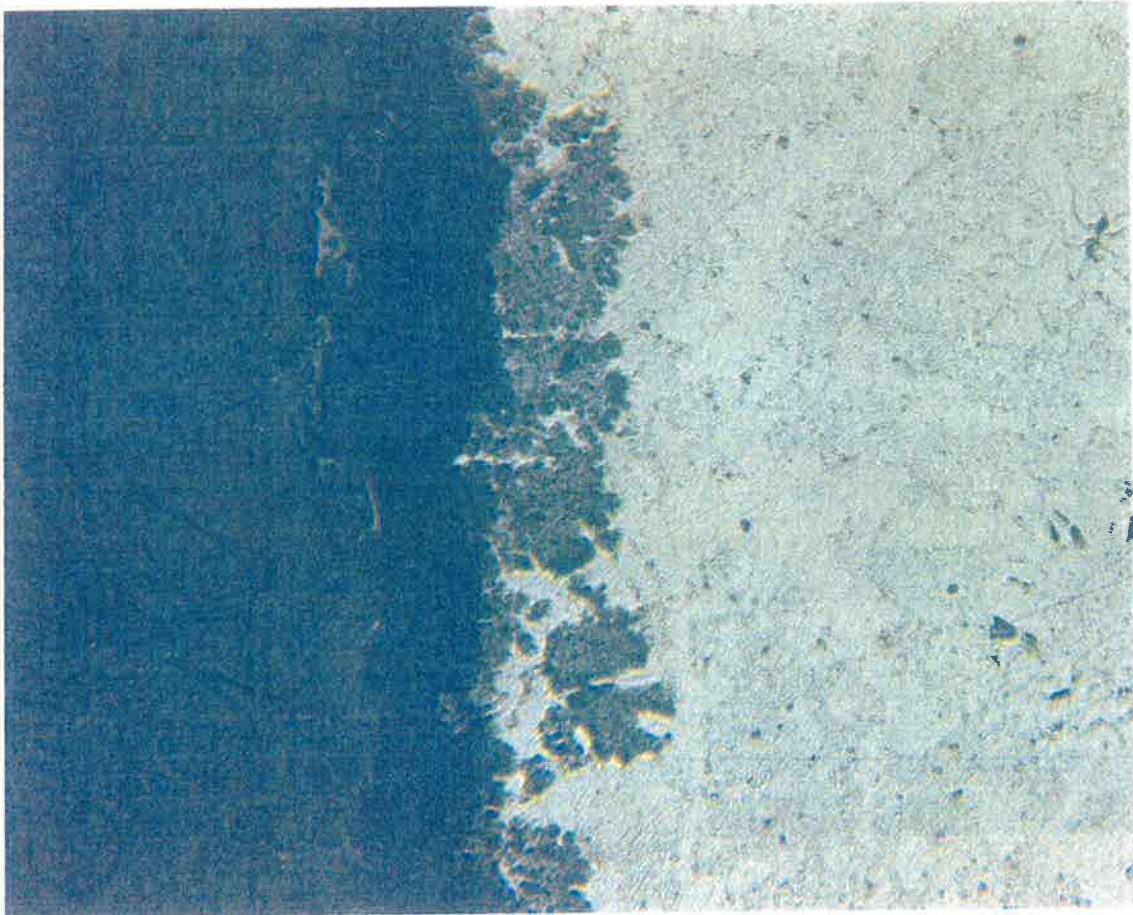
Photo 81 - Sample 5 - Cross Section Micrograph - Graphitized Area - 100X

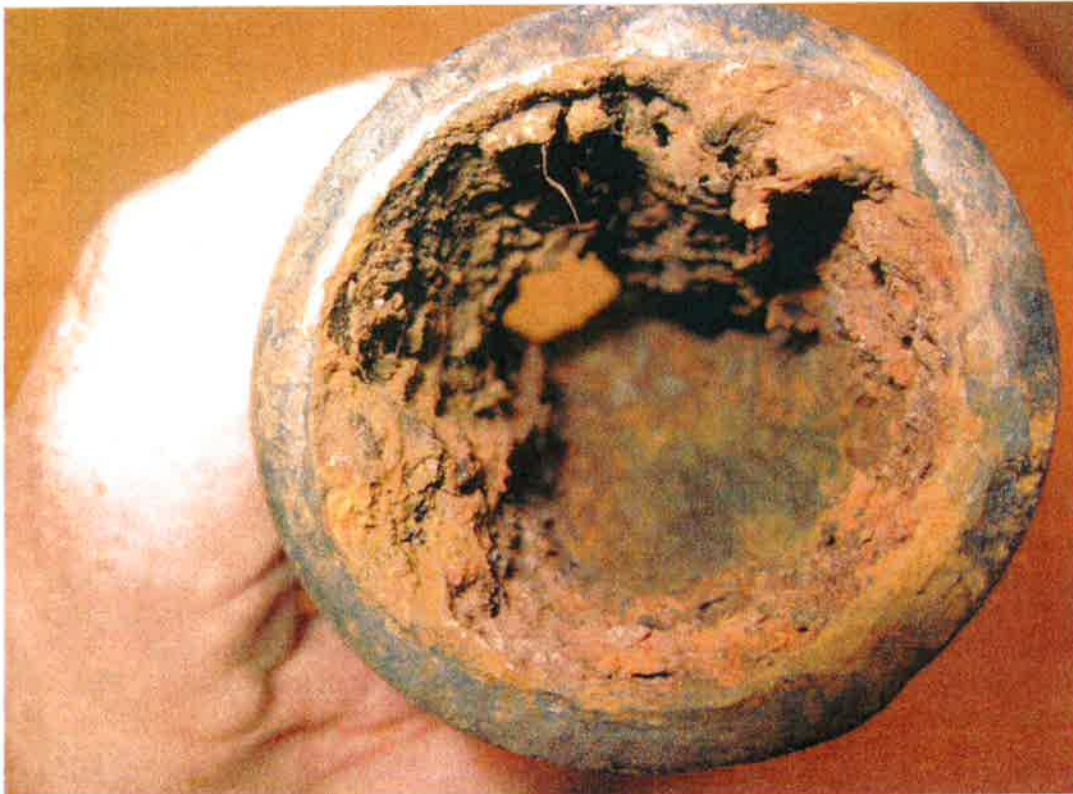
Figure 1 – Inside of 1/8<sup>th</sup> bend fitting (Sample 1).

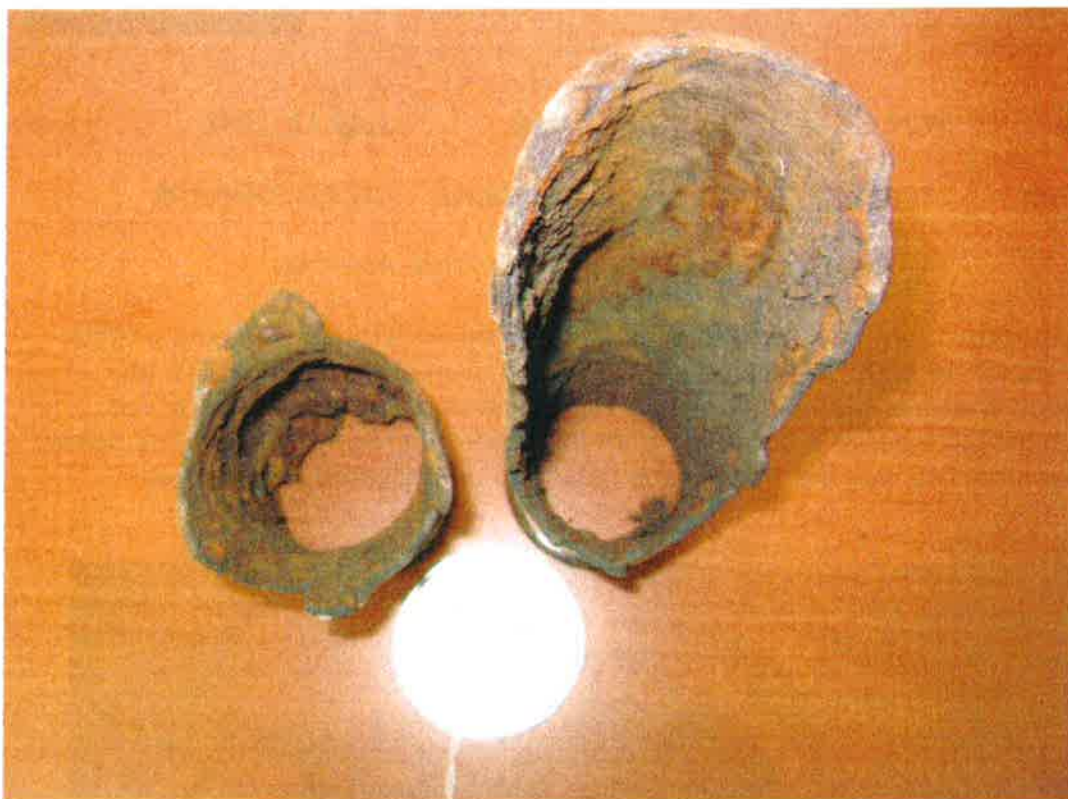
Figure 2 – Sample 2 – Fourth floor Tee.

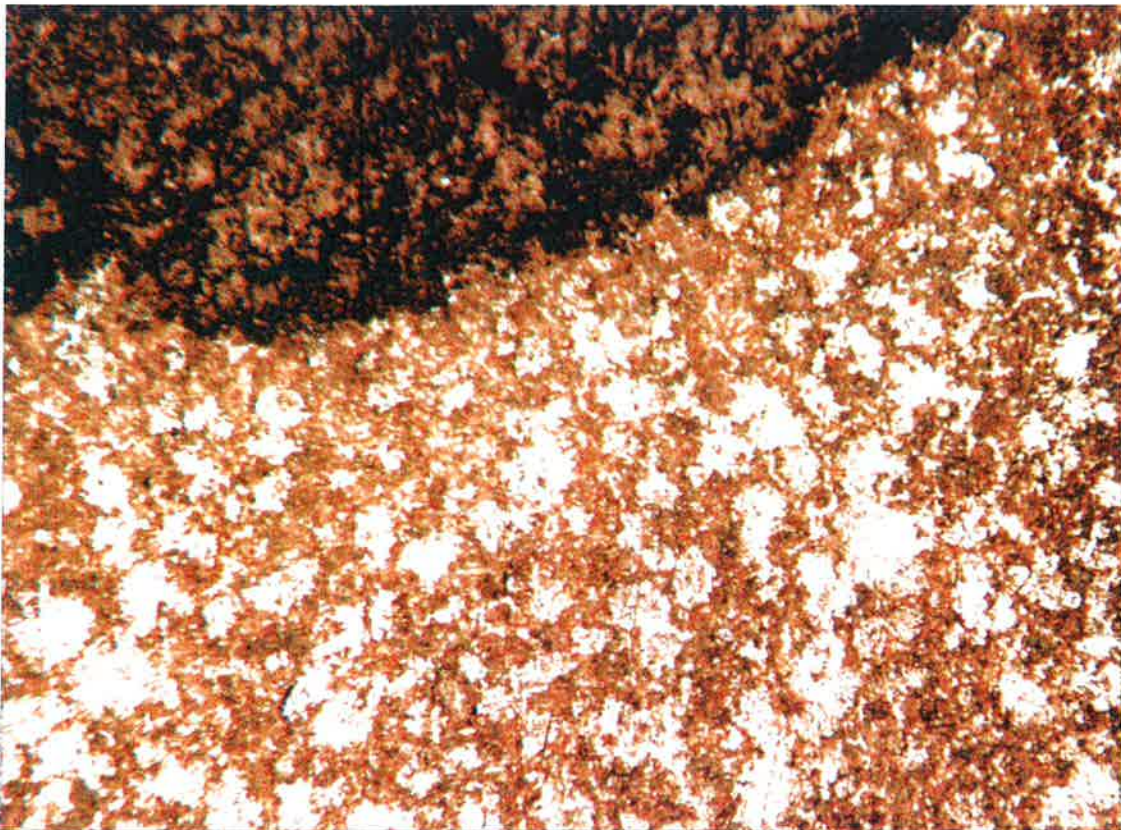
Figure 3 – Sample 1 at 100x. Black at top left is an intact porous layer of corrosion product & graphite. “Brighter” material is compromised base metal that has not yet been completely leached away.

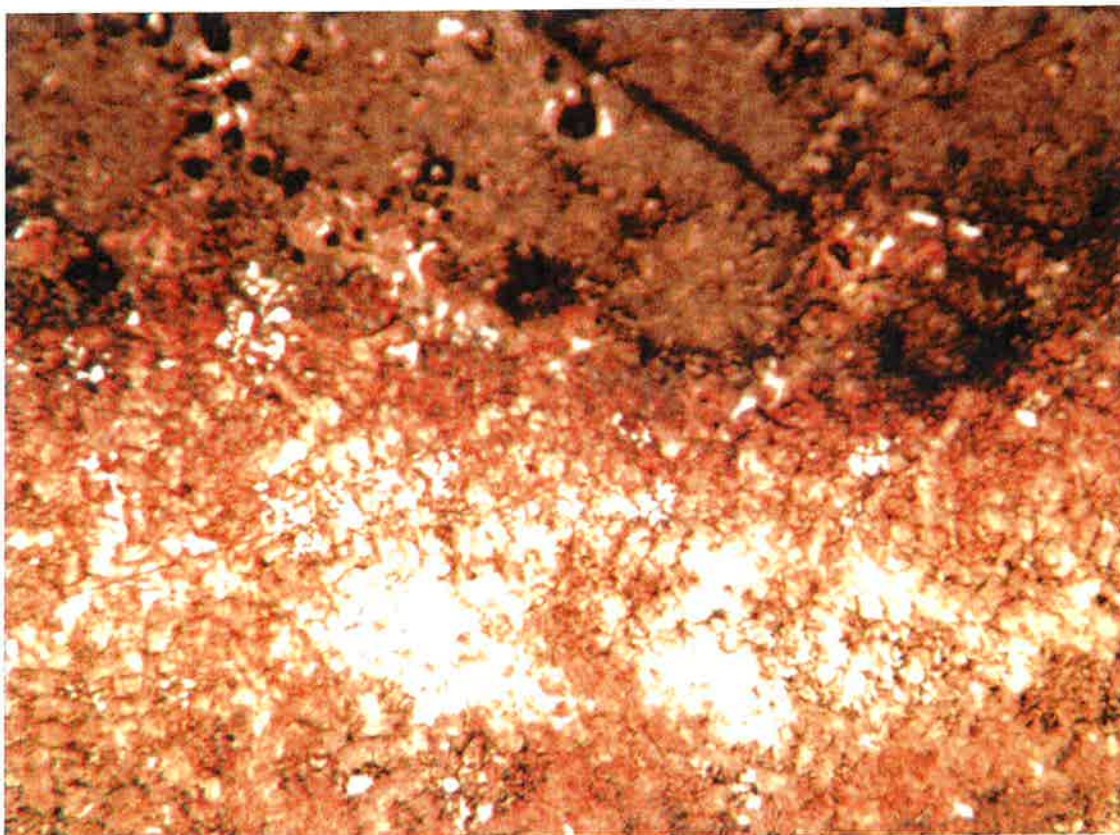
Figure 4 – Sample 2 at 200x. Close-up of the graphite (top)/ compromised metal interface.
